Typical conservation problems of polychrome wooden sculptures in Slovenia

Case study: removal of overpainting from gilded areas of a wooden sculpture

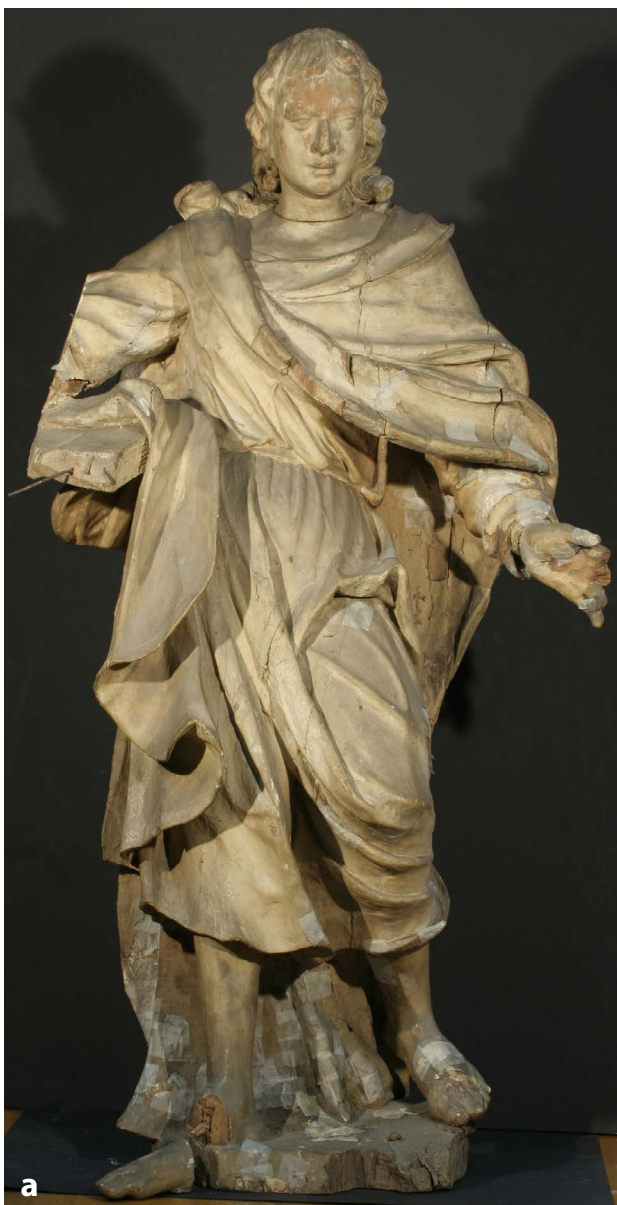
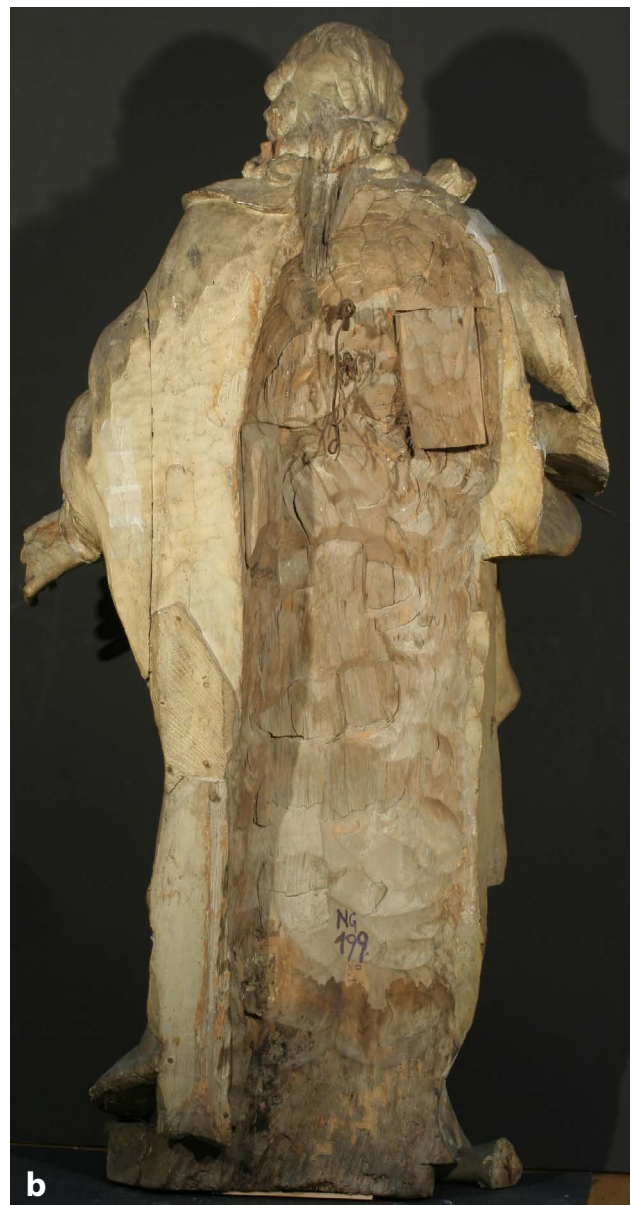
The presented case study is an example of a recently treated 18th century sculpture of Saint John the Evangelist from the National Gallery of Slovenia. The sculpture was separated from its original retable in the past and later became a part of a museum collection. The progressive changing of surfaces in the past has resulted in the alteration of original colours. The sculpture, originally water gilded, was subsequently overpainted several times. In conservation terms, the structure of the sculpture was good, but the surface was adulterated (Figure 3).

Figure 3. Saint John the Evangelist, attributed to Heinrich Michael Löhr, 18th century. Polychromed and gilded wood; h. 160 cm; National Gallery of Slovenia NG P 199. The sculpture is composed of several constituent elements; the main part of the figure was carved from a single block of wood and its back side is hollowed out. In the past sculpture was painted in greyish white. Before treatment. Photo: Vuga Martina, National Gallery of Slovenia.

The sculpture is composed of at least sixteen pieces of wood. The main part of the figure was carved from a single block of wood and its back side is hollowed out (Figure 3).

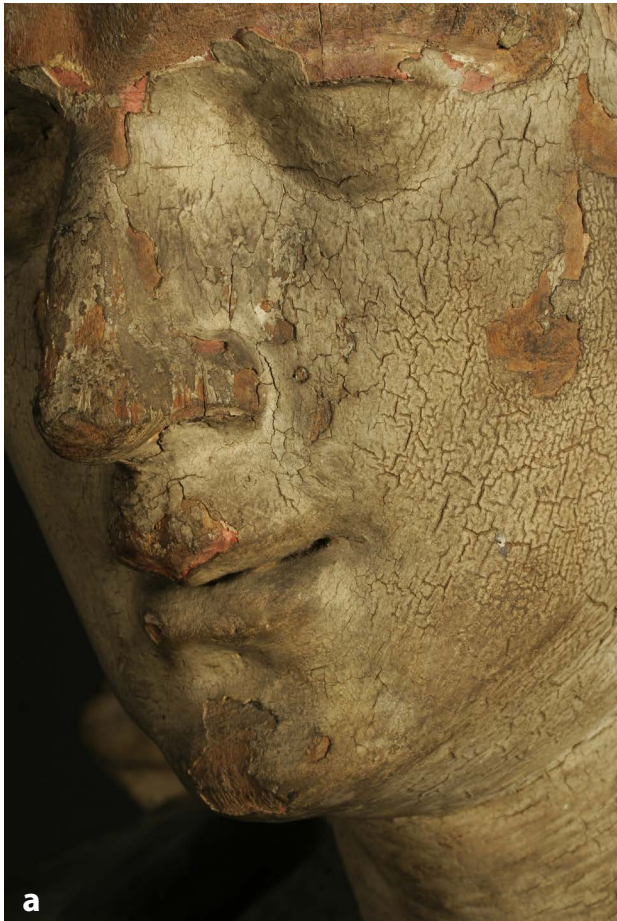
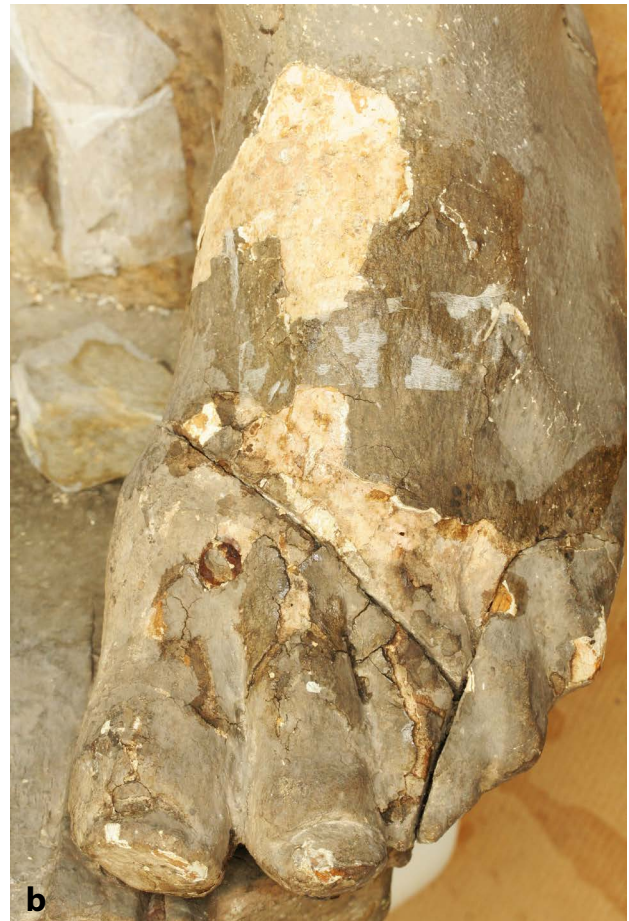
Figure 4. Details of the Saint John the Evangelist. Condition of the ground and paint layers before treatment. Overpaintings delaminated, fallen off in some isolated smaller areas, and coloured layers were visible underneath e.g. above the upper lip and the nose, carnation on the foot. Photo: Vuga Martina, National Gallery of Slovenia.

outside position, maybe a niche on the facade. The most recent greyish white colour, possibly as an imitation of marble stone had presumably been put on the sculpture before moving it outside (Figure 3). These overpaintings delaminated, fell off in some isolated smaller areas, and coloured layers were visible underneath, e.g. just above the upper lip, on the neck, the nod of a cloak and on the hair (Figure 4).

The condition of the ground layer on the major part of the surface was acceptable as could be assumed from the generally acceptable condition of the paint layer. However, some extensive losses of the ground layer, together with the paint layer, had occurred. Most of the damage of the ground layer was found on the areas exposed to water: the forehead, the upper side of the book, the bottom part of the cloak behind the Saint's legs, the Saint's feet and the upper side of the pedestal. Additionally, there were some scattered losses, a couple of square centimetres large, on the cheeks, nose, upper lip and chin. Some cracking and lifting of gesso layer occurred especially above the loose joints (Figure 4).

There was a network of cracks on the major area of the paint layer, but there were also parts with no cracks (right arm with a cloak). The paint layer was greatly damaged on the parts exposed to standing water. The surface was covered with a heavy layer of grime that had accumulated over time (Figure 4).

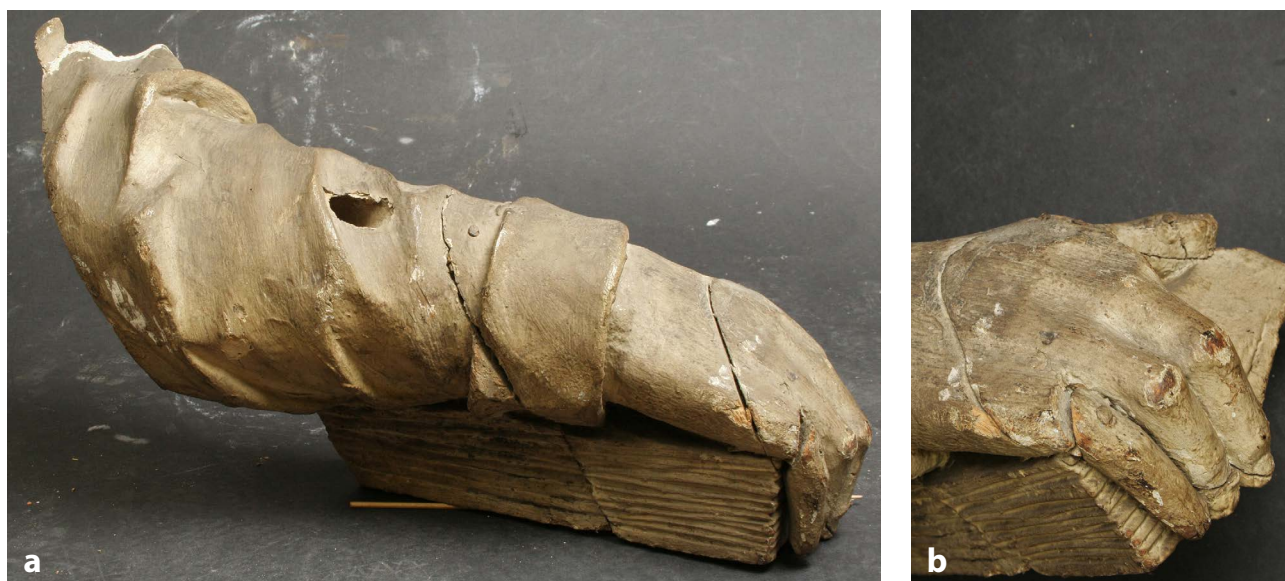
Several removable/separate parts were added. Some of these are bigger, e.g. the head, the Saint's right arm with a part of the book, the left arm with a part of the garment, the right and left hands, and the left foot, whereas some parts are smaller, such as fingers or finger tips, etc. (Figure 5).

Figure 5. Details of the Saint John the Evangelist. Constituent elements of the sculpture: *a*) the Saint's right arm with a part of the book; *b*) hand with smaller separate elements of fingers and finger tips. Photo: Vuga Martina, National Gallery of Slovenia.

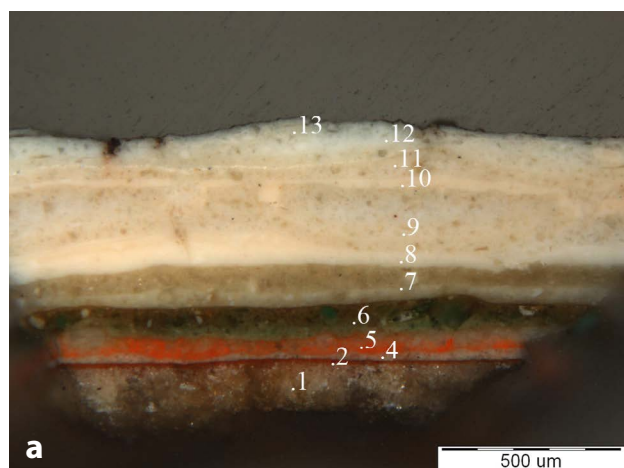
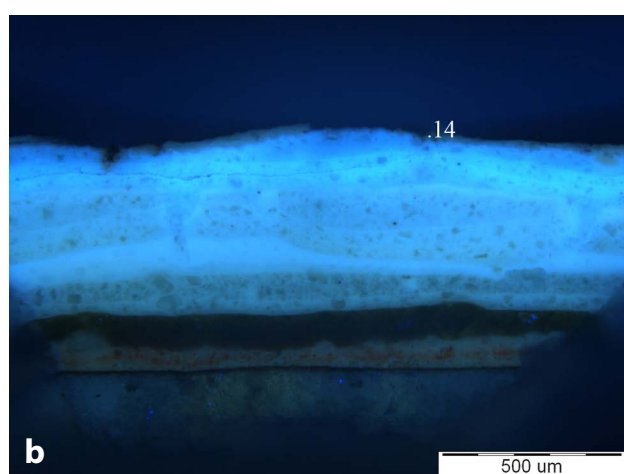
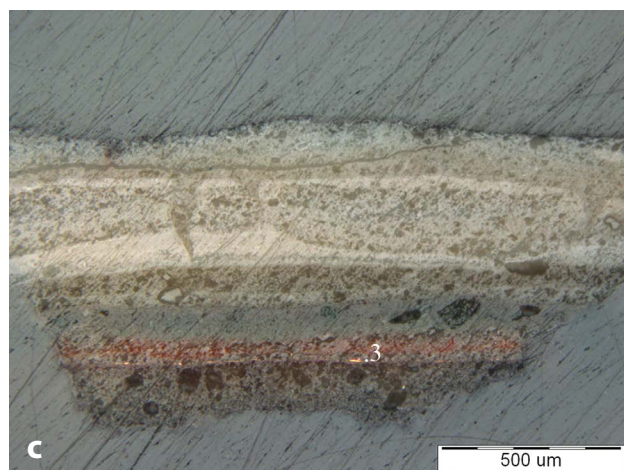
Figure 6. Cross section of paint stratigraphy from the lower part of the Saint's garment. Microphotograph at 10× magnification: *a*) visible light; *b*) ultraviolet radiation; *c*) polarized visible light. Photo: Kavkler Katja, IPCHS RC.

Cross section sample JEK 3: 1) Ground layer (calcium sulfate); 2) bole (red ochre); 3) gilding; 4) white (lead white, barium sulfate); 5) red (minium, lead white); 6) green, two layers (emerald green, lead white, barium sulfate, calcium carbonate, cinnabar); 7) translucent white; 8) white; 9) translucent white; 10) white-thin layer; 11) translucent white; 12) white; 13) white; 14) varnish, remains.

at least ten layers of overpainting of which six to seven are uniformly greyish white and four are coloured. Two samples taken from the Saint's garment suggested water soluble ground layers composed of calcium sulphate and red bole used for the original water gilding (Figure 6).

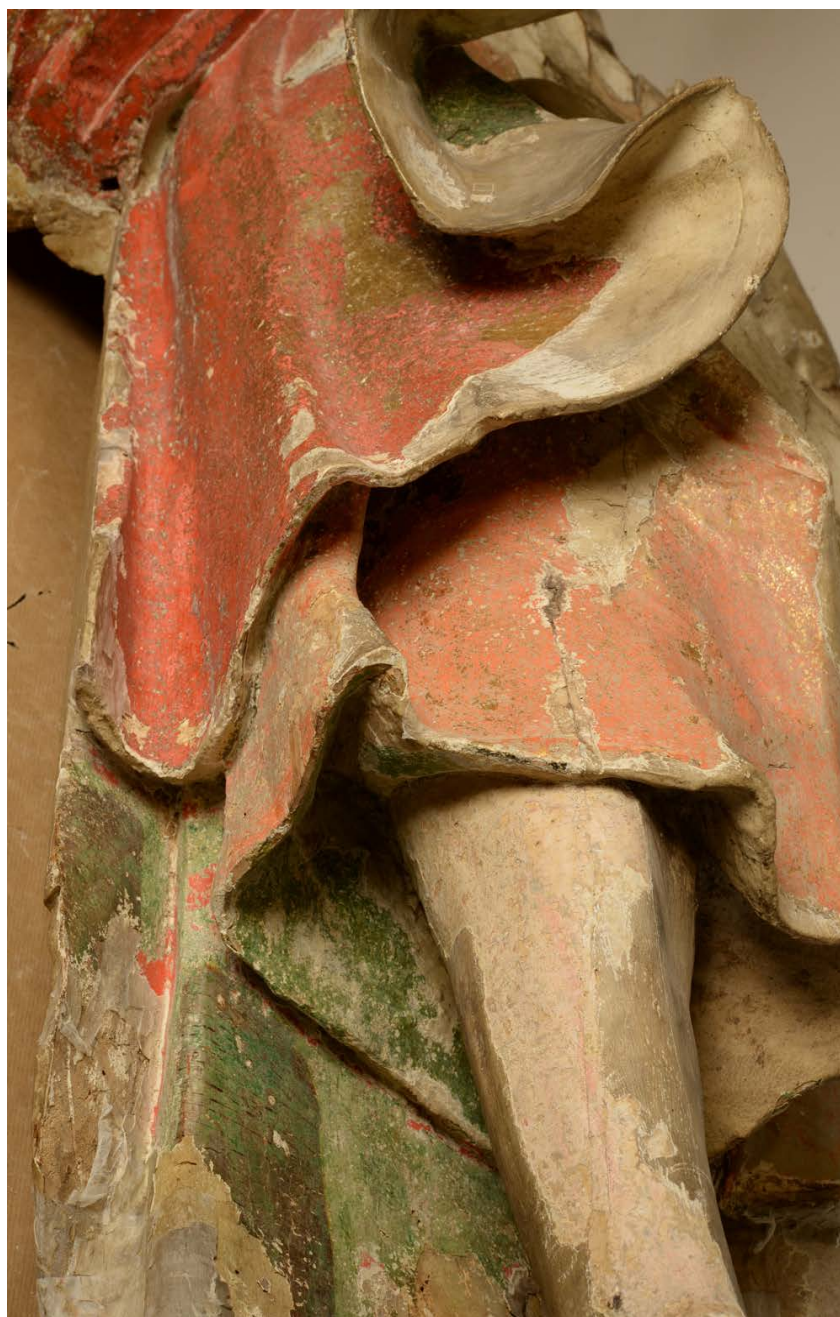
Figure 7. Detail from Saint John the Evangelist's garments after removal of white layers of overpainting. Photo: Vuga Martina, National Gallery of Slovenia.

Overpaint removal was done in two steps. The first step was the removal of white overpaint layers. It was possible to achieve the best results by mechanical means. A very limited swelling of white layers was reached after long-term applications of gelled ethanol. Six to seven white layers were relatively safely removed as they more or less easily delaminated from the last coloured layers of overpaint (Figures 7-8).

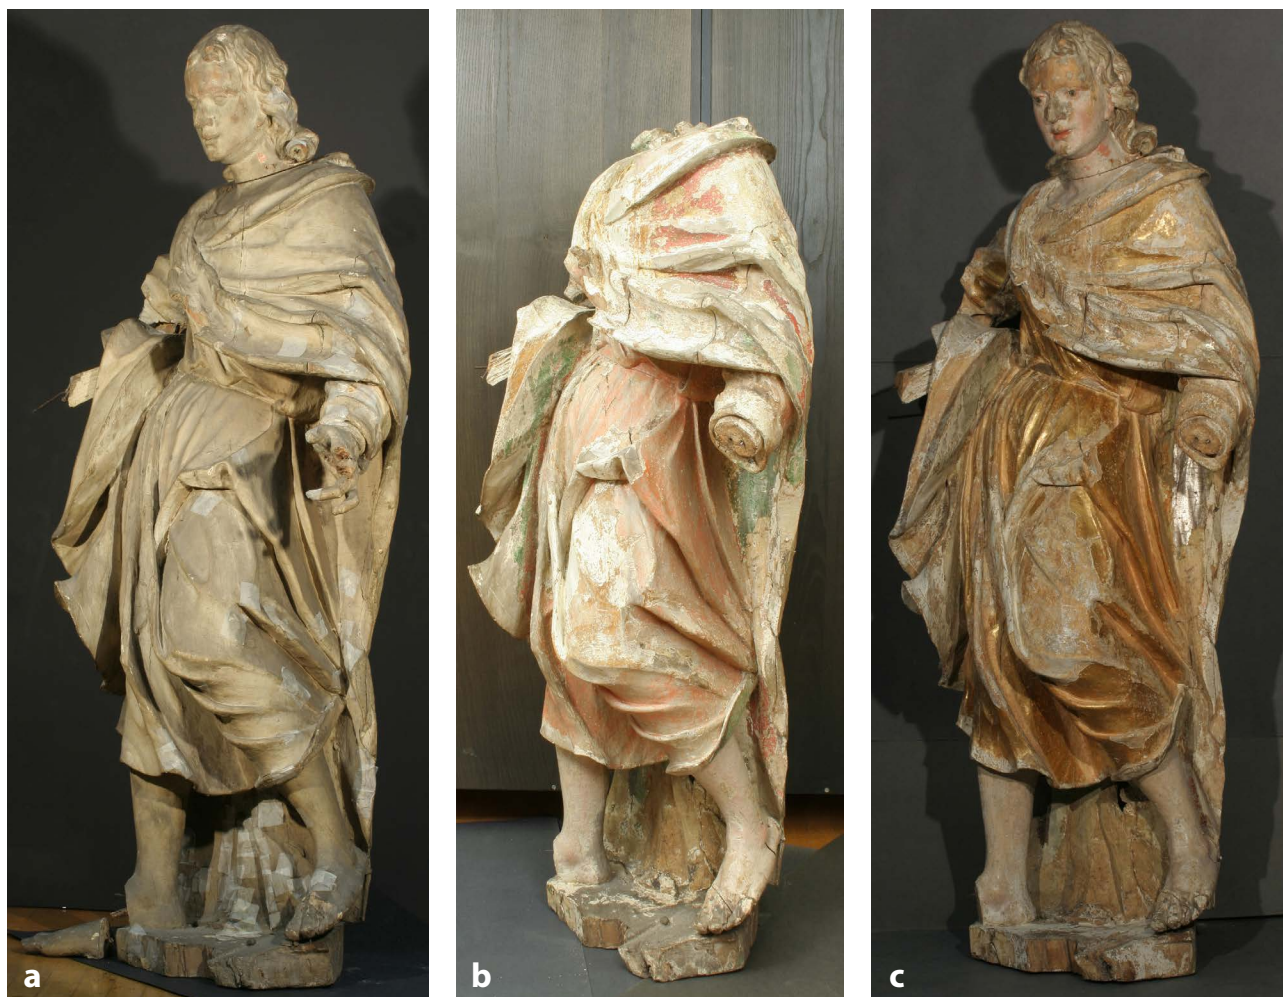
Figure 8. Saint John the Evangelist: *a)* before treatment; *b)* after removal of white overpaintings; *c)* after removal of coloured overpaintings. Gilded garment and gilded and silvered cloak. Photo: Vuga Martina, National Gallery of Slovenia.

The complete removal of white layers revealed the extent of the damage (most probably) caused to the original ground and paint layers by water flow even before the sculpture was painted white. Those parts that had been safe(r) from flowing and/or standing water thanks to their position, e.g. under the folds of the garment, were well preserved, whereas the parts that had been exposed to water flow were destroyed: the ground and paint layers detached and were missing, e.g. the upper sides of the cloak. Even greater was the damage caused to the bottom part of the sculpture which is part of the pedestal where water probably stayed, e.g. behind the legs on the inner side of the cloak.

This intermediate phase presented the condition of the sculpture before it was overpainted white for the first time (Figure 8b). White overpaintings layers were applied also over the damaged parts, without a ground layer, directly on the wood.

In the next step, after removal of coloured overpaintings we have managed to get to the original gilding preserved on a large area (Figure 8c).

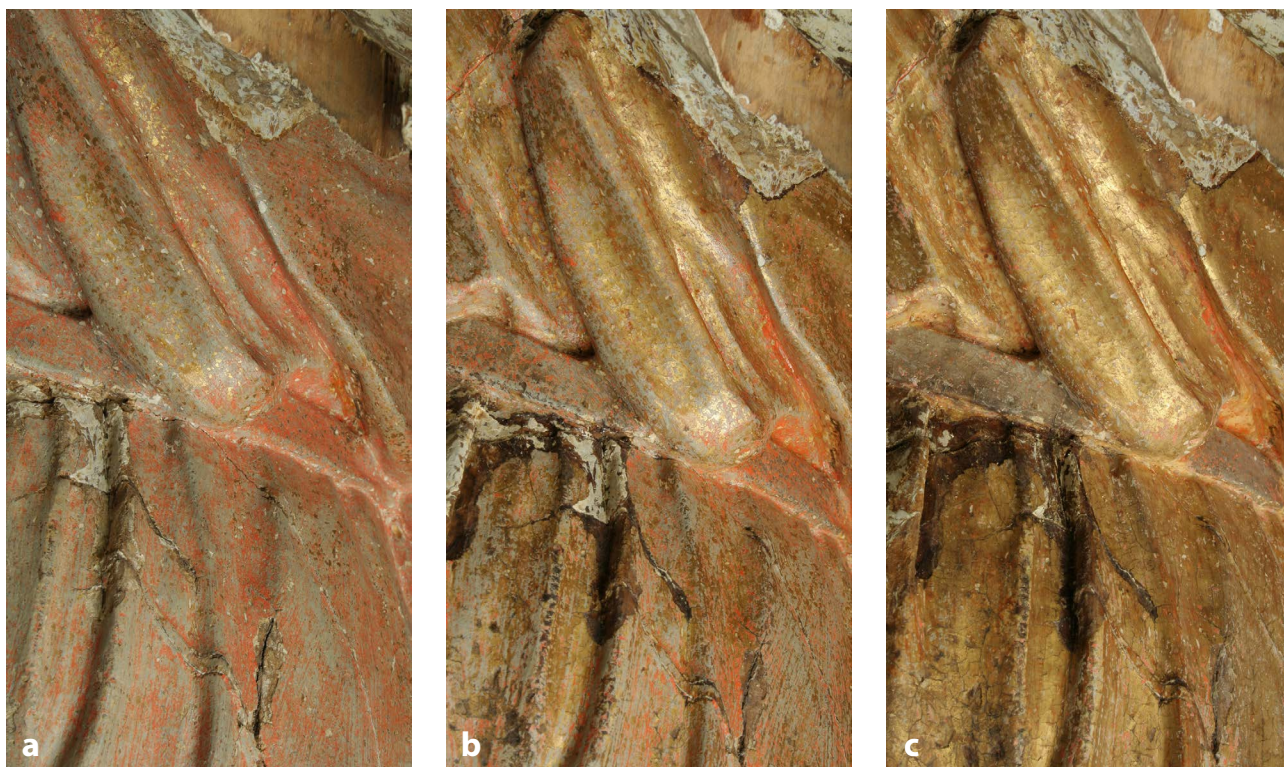
Figure 9. Detail from the Saint John the Evangelist's garment: gradual thinning and removal of coloured overpaintings revealed water gilded garment with silver belt. Photo: Vuga Martina, National Gallery of Slovenia.

Testing the removability of the remaining overpaints was repeated in the next step in order to find the safest way to reveal the gilded areas. Different solvent/detergent systems were chosen to soften the surface of the overpaints. The greyish and red overpainted layers on water gilded garment were softened with a polar solvent surfactant gel made of benzyl alcohol, Ethomeen C25, Carbopol and a small quantity of water. Red and green overpaints on the outer part of the cloak were removed by using a non-polar solvent surfactant gel made of a mixture of solvents (Petrol T_b 100-140 °C, Shellsol A and Benzyl alcohol in ratio 4:1:0.8), Ethomeen C12, Carbopol and a few drops of water.

Applications of gel for 3 to 4 hours and covered with Melinex polyester film were repeated several times. The remains of overpaint were removed with using a scalpel and a solvent solution (Figure 9).
