Cause of decay and intervention on external mortars of the S. Vittore Church - Stresa (Italy)

Massimo Valentini

Raffaello Visentini

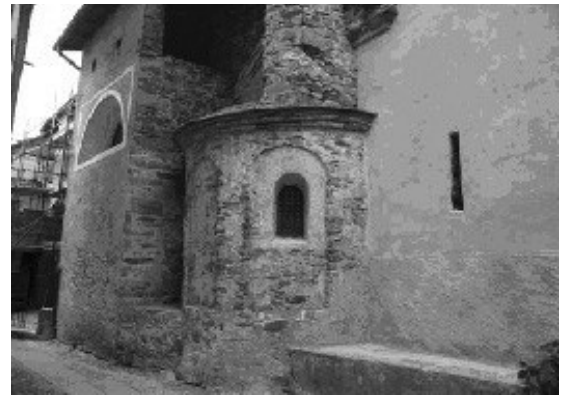
The external masonries of the church are plastered, except for a portion of the Romanesque part exposed to the north-west with cutstones at sight and only some traces of original plaster (Figure 1).

Fig. 1 The north-west side of the Romanesque part of the church.

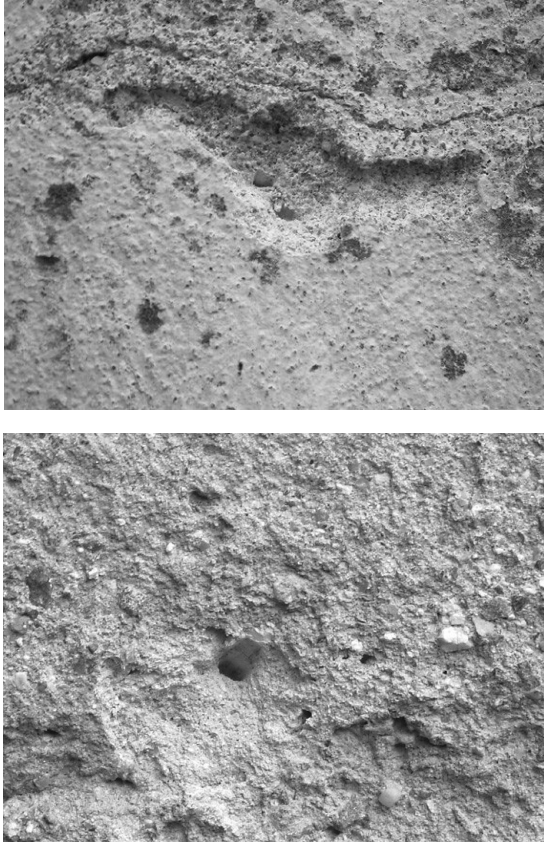
Fig. 3 The different appearance of the older plasters (above) and recent one (below).

The analyses on the external plasters had analytically to explain the visible difference between the older plaster (in the Romanesque part of the church) and those most recent in the rest of the building (Figure 3) and to characterize the bedding mortars of the Romanesque part. Sampling was carried out taking into account minor damage to the walls; for this reason, rendering pieces were obtained at edges where detachment was initiating on three sides of the church (excluding the facade). In order to obtain as complete as possible a characterization so as to enable later execution of similar mortars based on the information gathered, X-Ray diffraction (to determine the mineralogy) and observation of thin section by optical microscopy with transmitted and polarized light (to check mortar's microstructure) were carried out.

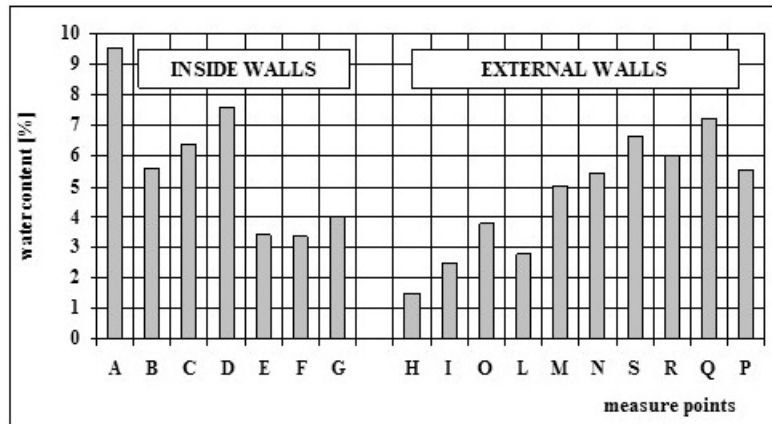
The water is distributed in a non uniform way in the various inquired walls. The average water content values (measured in all points of measure of the Figure 2 at 10 cm height from the floor plane) are shown in Figure 4.

Fig. 4 Average water content.

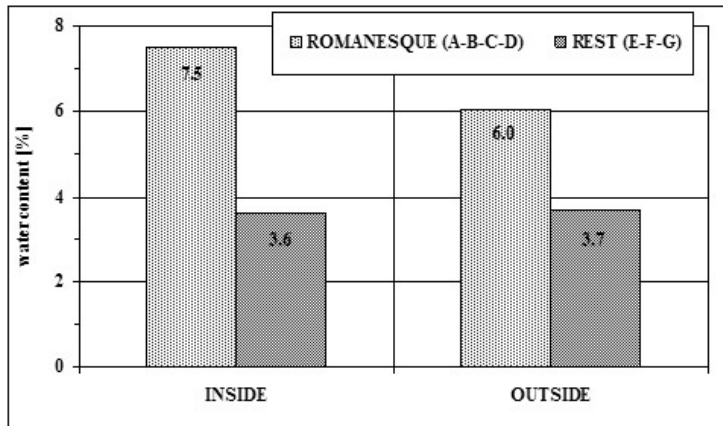
The Romanesque portion of the church shows the greater water contents in masonries (Figure 5) without

difference between the different sides of the building. The result is in accordance with the greater decay of this part of the building drawn above.

Fig. 5 Comparison between the average values of water content of masonries measured in the Romanesque part and in the rest of the building.

The results of the diagnostic measurements and their analysis have therefore addressed the plan towards a first outdoor intervention of water-drainage of the strips of land that encircle the foundations of the building (upon the cliff).

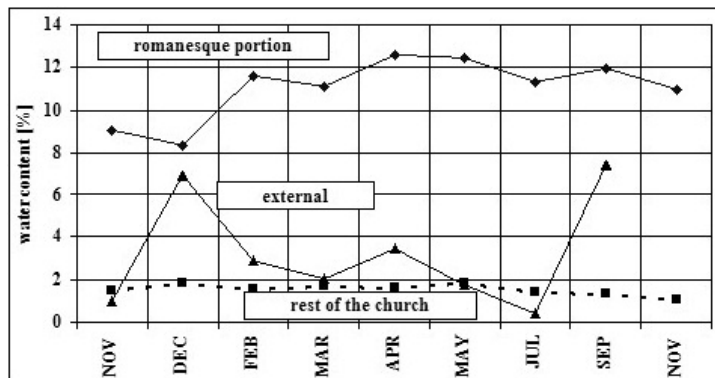
PPM method has allowed to verify the variations in time of the values up to here indicated in absolute terms. The Romanesque part of the church has also the greatest water content values: the water in the walls keeps high and almost constant for great part of the year. In the rest of the church, on the contrary, the water contents are low. The outdoor walls show a greater variability in accordance with the unsteady evaporation caused by air movement (Figure 6).

Fig. 6 Water content vs. time.

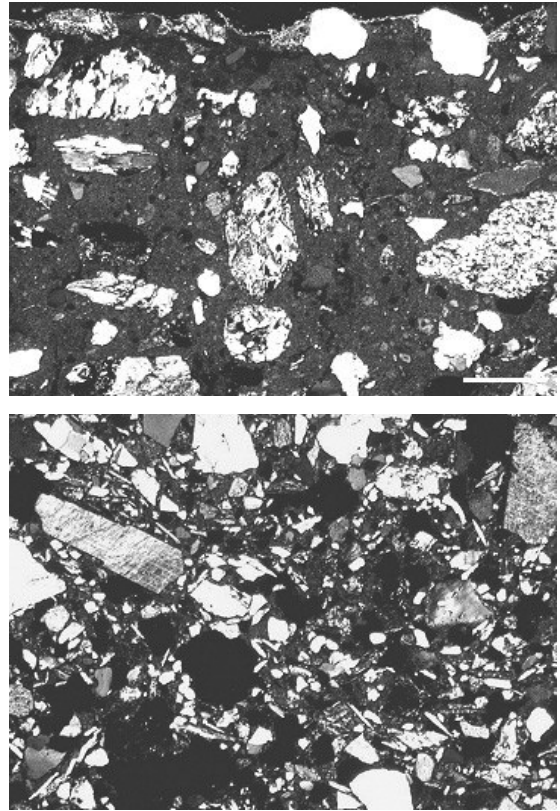
Samples indicated as “ancient” are characterized by mortars with weakly magnesian lime binder with micritic texture and with irregular shaped cavities. The aggregate is made of silicate sand with angular quartz rounded metamorphic rock. The aggregate show a variable granulometry from 0.2 to 1.0 mm (cliff fragments have greater dimensions that can arrive to 3-4 mm). The binder-aggregate ratio is approximately 3:2.

The “recent” plasters have the same mineralogical-petrographic nature of the “ancient” one, but show a minor percentage of the aggregate, with a binder-aggregate ratio 1:1 (Figure 7).

Fig. 7 Thin sections of a sample of “ancient” (above) and “recent” (below) plaster observed with the optical microscope in polarized light (bar = 100 μm).

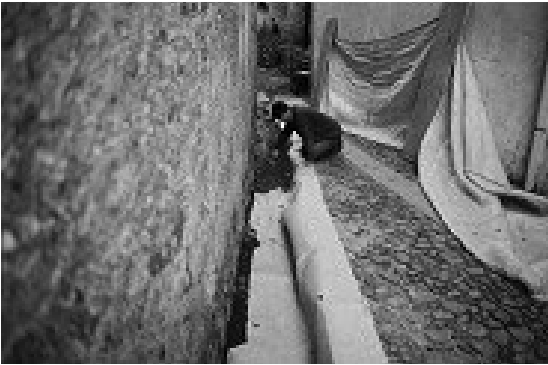
Fig. 8 The excavation and the drain strip around the church.

Following the indications of the diagnostic investigations discussed in chapter 4.1, the first outside intervention on the building had the aim of removing from the church the meteoric water that falls in the proximity of it. In an excavation carried out around the building, a drainage

pipe has been put down and connected to the public water discharging; all the down-pipes of the meteoric waters collection plan have been connected to the same canalisation. The excavation has been then covered with a gravel layer of various diameters in order to obtain an effective water-drainage (Figure 8).

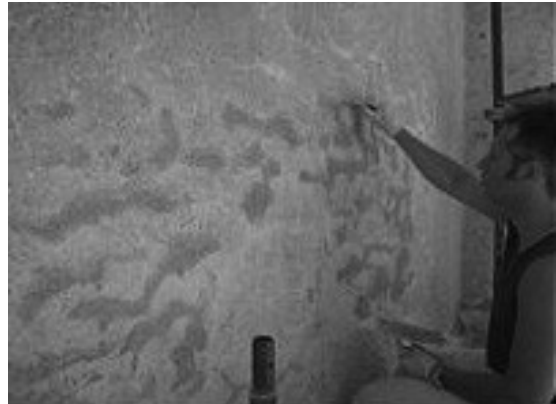
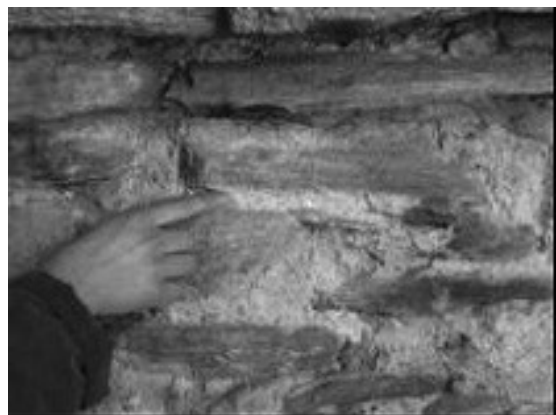
Fig. 9 An example of integration of gaps of the external plaster (above) and of the bedding mortar (below).

After the first phase of cleaning and consolidation (with injections of hydraulic lime and micronized binder) of the plasters, the phase of integration of gaps has been carried out following the diagnostic indications: using therefore the same compounds (seasoned air lime and different granulometry aggregates: fine sand, sand with diameter 1 mm, gravel from 5 to 9 mm, quartz crystals with size from 3 to 7 mm, micronized “cocciopesto” with diameter from 1 to 6 mm) for every single integration their ratio has been varied so as to integrate it with the existing plaster to match its granulometric and chro-

matic appearance (Figure 9). When necessary, a chromatic veiling with watercolour has been executed to better meet the original plaster colour.

The same procedure and materials have been adopted for the integration of the bedding mortar of the Romanesque portion of the church.
