Application and properties of pure lime façades – case study

Violeta Bokan Bosiljkov

Abstract

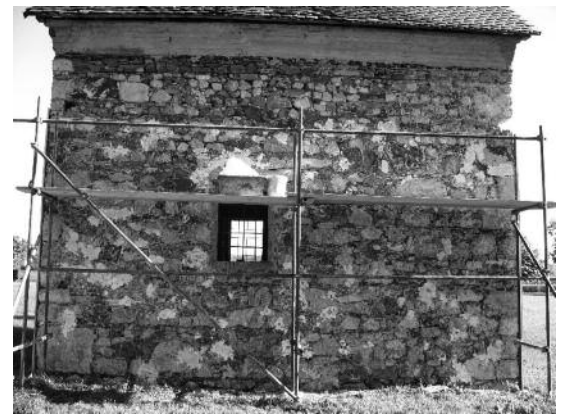
lichens and dirt, and also weak parts of mortar between stones (Fig. 1). Several voids between stones with volume between 1 and 3 dm³ were filled with rough lime mortar prepared with lime putty from Tržič and smaller stones (Fig.2). Details of the mortar are given below.

Fig. 2 The test wall after filling of voids.

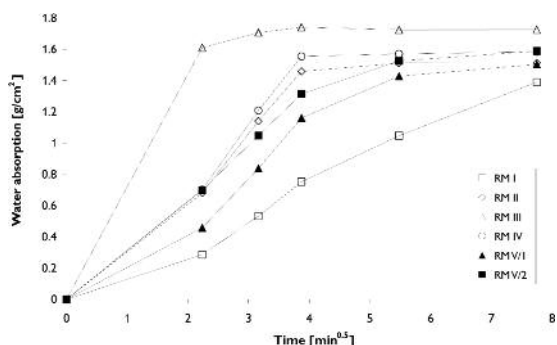
In order to determine the compressive strength (SIST EN 1015-11, 2001) and water absorption (SIST EN 1015-18, 2004) of the rough mortars for rendering layers, standard 40x40x160 mm prisms were cast and tested at the age of 90 days. The test results are given in Table 3 and in Fig. 3. Water absorption coefficients were determined according to [6].

Fig. 3 Results of water absorption test on prisms from different rough lime mortars.

Table 3 and Fig. 3 show that RM III is the mortar with the coarsest pores (the most rapid water absorption) and RM I the mortar with the finest pores (the slowest water absorption); the other mortars are in-between.

Results of on-site water absorption tests conformed to the results of laboratory tests (Fig. 3) in that RM III is

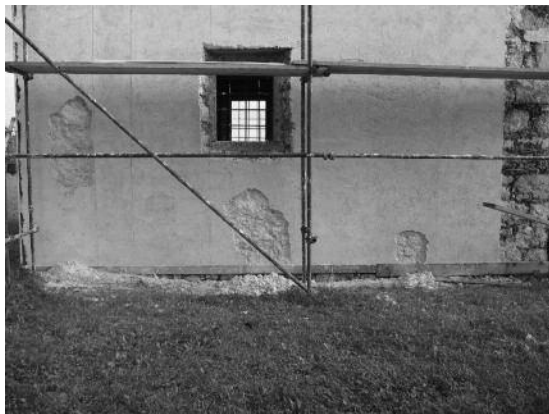
The first stripe of rendering layer applied on the wall was layer RM II, followed by layers with RM I and RM V/1 (last on the right side – Fig. 4) in the same day. During the next day layers with numbers V/2, III and IV were applied. After the rendering layers had been finished, it started to rain and it was raining for several days. Therefore some thicker parts of layers made from mortars RM I and RM IV, and from below the window were falling from the wall (Fig. 5). They were restored using the same mortar mixture and after that the renders behaved very well, as can be seen from the picture in Fig. 6, taken in October 2007.

Fig. 5 Thicker parts of rendering layers were falling from the wall after rain.

The high thickness of rendering layers in some areas was estimated as problematic. We believe that the decision for an even rendering surface and thus very thick parts of rendering layers on rubble masonry was not appropriate. The rendering layer should be carried out

by throwing the mortar and subsequent floating and troweling, in order to obtain compact render with maximum thickness of 2 cm.

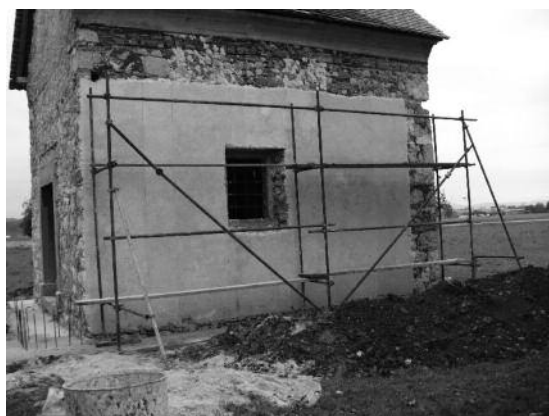
Fig. 6 Rendering layers after 1 year.

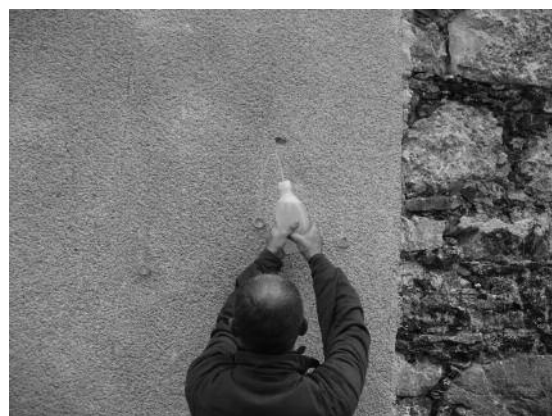
After 1 year, in October 2007, fine finishing layers were applied. Just before that, the water absorption tests and the determination of carbonation depth were carried out. The pipe-method (RILEM test N° II.4 of RILEM commission 25-PEM) was used to measure the quantity of water absorbed under low pressure by a definite surface of a porous material and after a definite time. The pipe is applied on the material by interposing a tape of putty. Then the pipe is filled with water through the upper opening up to the graduation 0 (Fig. 7). The quantity of water absorbed by the material in function of time (after 5, 10, 15, 30 and 60 minutes) can be read directly from the graduated tube. The measurement positions of the pipes are given in Fig. 4, by points. The determination of carbonation depth was first carried out by the phenolphthalein method. However, by removing part of the render, noncarbonated particles contaminated the carbonated part and the obtained results were useless. In the next step we focused on removing noncarbonated parts of renders, with considerably lower resistance to scratching, using a steel brush, and measured the remaining carbonated part (Fig. 8). The parts of renders were removed on the lower side of each particular stripe, where conditions were less favourable for carbonation, due to relatively higher humidity.

Fig. 7 Water absorption tests on rendering layers.

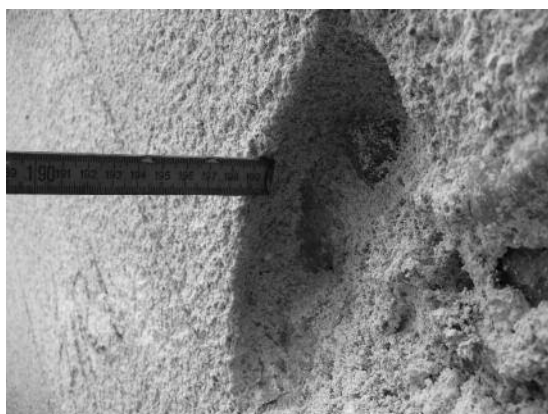
Fig. 8 Determination of carbonation depth of renders.

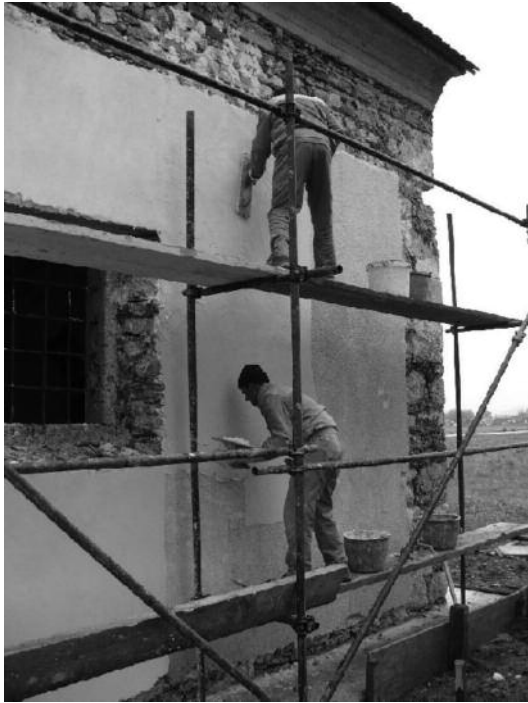
Fig. 11 .Application of finishing layer (two-coat work).

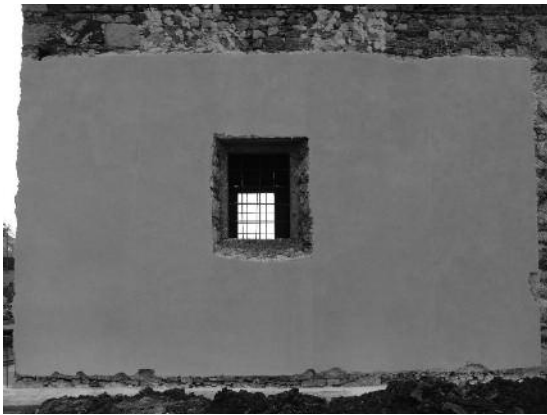
On 25th and 27th of October 2007 the finishing layers were painted with lime wash coloured with yellow ochre pigment (Fig. 12) and thus the façade was completed.

Fig. 12 Finished façade – after application of coloured lime wash.
