Evaluation of compatible mortars to repair 19th century natural cement cast stone from the French Rhône-Alpes region

Myriam Bouichou

Emmanuel Cailleux

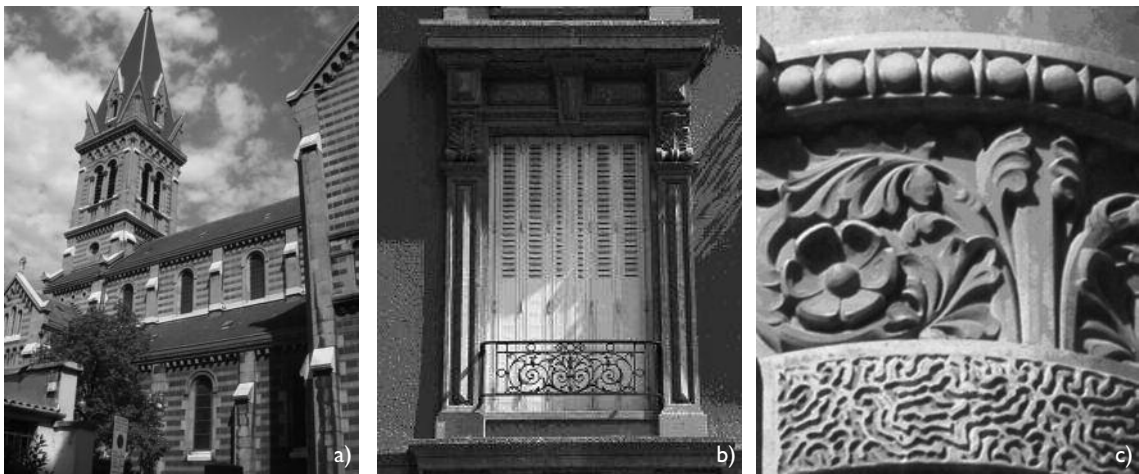
Fig. 1 Examples of natural cement applications in the French city of Grenoble: a) concrete blocks; b) window frame; c) façade ornament.

In a preliminary survey, more than 60 buildings using natural cements were listed in the French department of Isère. Houses and apartment buildings constituted the majority of them, but a significant proportion of churches was also identified (Figure 1).

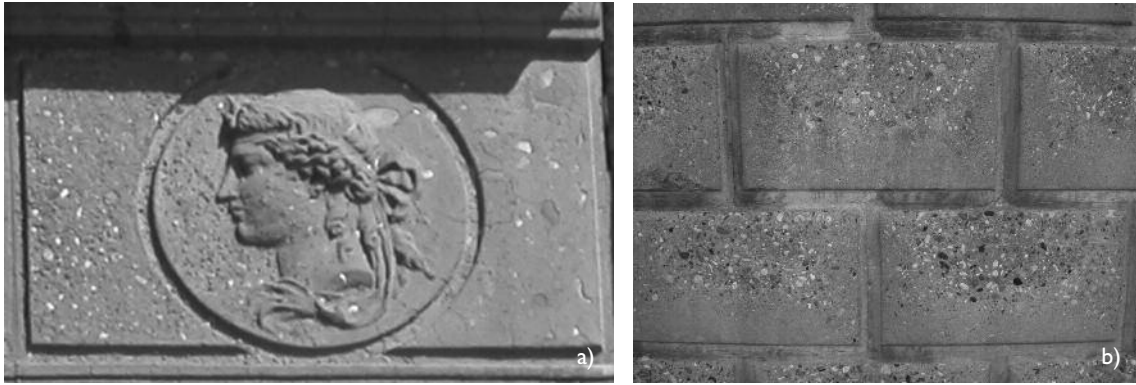
Fig. 2 Examples of erosion phenomenon observed either on sculptures (a), or on concrete blocks (b) in the city of Grenoble.

- an erosion phenomenon (Figure 2), which was affecting the surface of the majority of the buildings, leading to a progressive elimination of the concrete skin and to the appearing of the coarser aggregates. Consequently, the original aspect of the concrete blocks imitating free-stones is progressively lost, and a gradual degradation of the details of the sculptures is generally noticed;
- and a spalling phenomenon, which was observed only on a few buildings and which was sometimes associated with black crusts or white efflorescences.

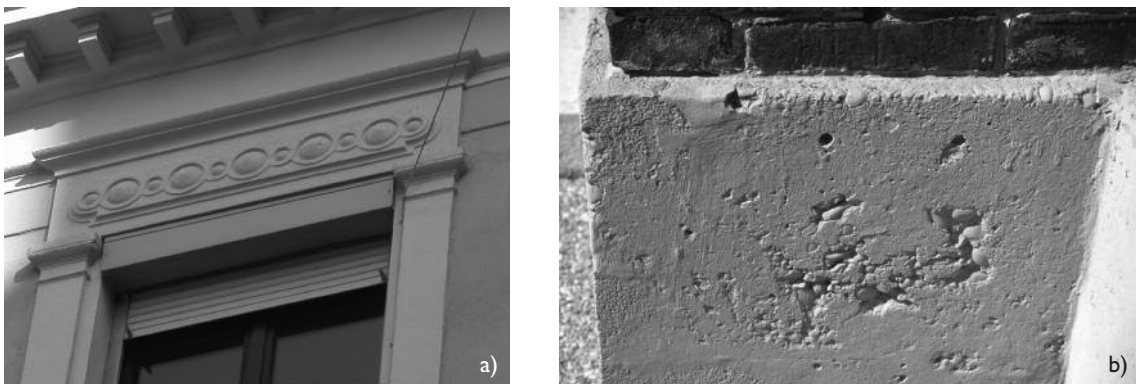
Fig. 3 A yellowish or brownish painting is generally applied on the ancient concrete, with (a) or without (b) preliminary application of a Portland-cement-based surfacing mortar.

brownish painting as finishing, are generally used (Figure 3). In some cases, painting is even directly applied on the ancient concrete, without preliminary application of a surfacing mortar.

With such rehabilitation techniques, the initial mineral texture and the numerous ochre shades encountered, which are very specific and which make those fake stones look so real, are lost. Moreover, as the composition of the natural cements of the French Alps region is very distinct of that of Portland cements, incompatibilities might occur.

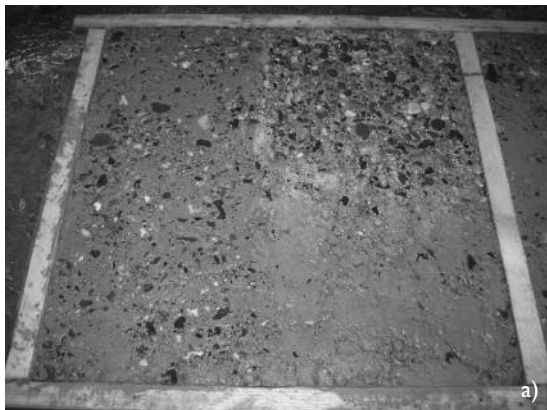
Fig. 4 To reproduce the eroded facies encountered on the ancient concrete to be restored, two deactivation products were tested, inducing 2 depths of deactivation (a) and (b).

To reproduce a surface similar to the erosion facies the more commonly encountered, 2 deactivation products were tested (Figure 4). The best results were obtained with the product inducing the higher depth of deactivation. It was then pulverized on the 20 slabs surfaces just after their casting.
