Cause of decay and intervention on external mortars of the S. Vittore Church - Stresa (Italy)

Massimo Valentini

Raffaello Visentini

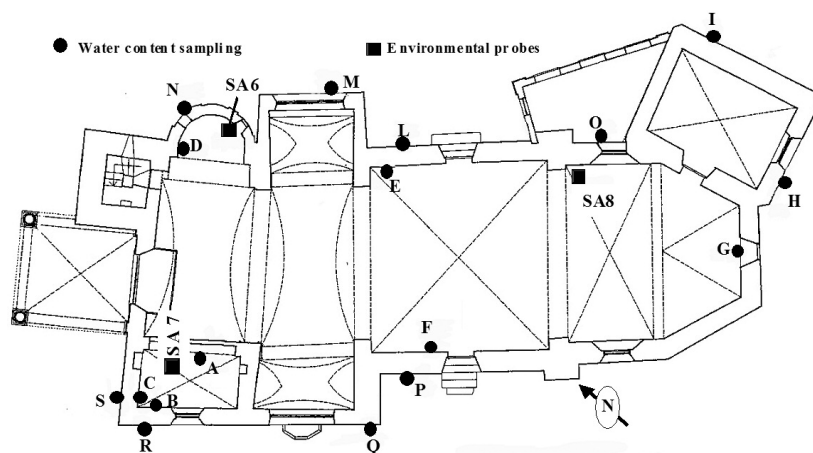
Fig. 2 Position of the zones of masonries water content measures (in some zones sampling has been carried out at various quotas from the floor plane) and of the probes for the indoor conditions monitoring.

The water is distributed in a non uniform way in the various inquired walls. The average water content values (measured in all points of measure of the Figure 2 at 10 cm height from the floor plane) are shown in Figure 4.
